NON-DESTRUCTIVE EVALUATION OF MIXING AND  
DEFECTS OF FRICTION STIR WELDED DISSIMILAR AA6061-  
T6 AND AZ31B BY X-RAY COMPUTED TOMOGRAPHY.

A thesis  
submitted in partial fulfillment of the requirements  
for the degree of Master of Engineering  
to the Department of Mechanical Engineering  
of the Maroun Semaan Faculty of Engineering and Architecture  
at the American University of Beirut

Beirut, Lebanon  
August 2019

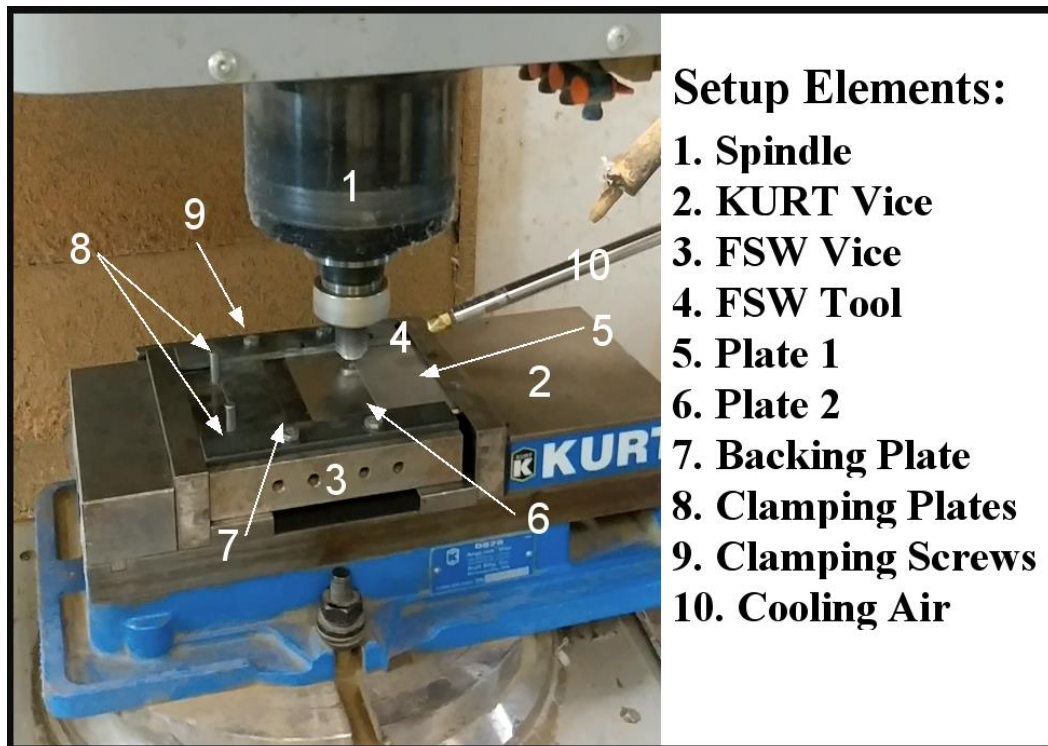
The welding was performed using a HAAS VF-6 5-axis milling center, to which a prebuilt FSW fixture is attached to enable welding. The plates are FSW'ed in a butt weld configuration. Figure 1 shows the FSW setup with the essential elements labeled, the FSW fixture (3) is placed in the KURT vice (2). The FSW Tool (4) is placed in the spindle (1) and the position calibrated to dimensions of the plates and the weld start position. The plates (5-6) are secured via the clamping mechanism (7-9). Dry compressed shop air (10) is used to cool the tool during and after each weld.

Figure 1 FSW setup diagram, key elements are highlighted.

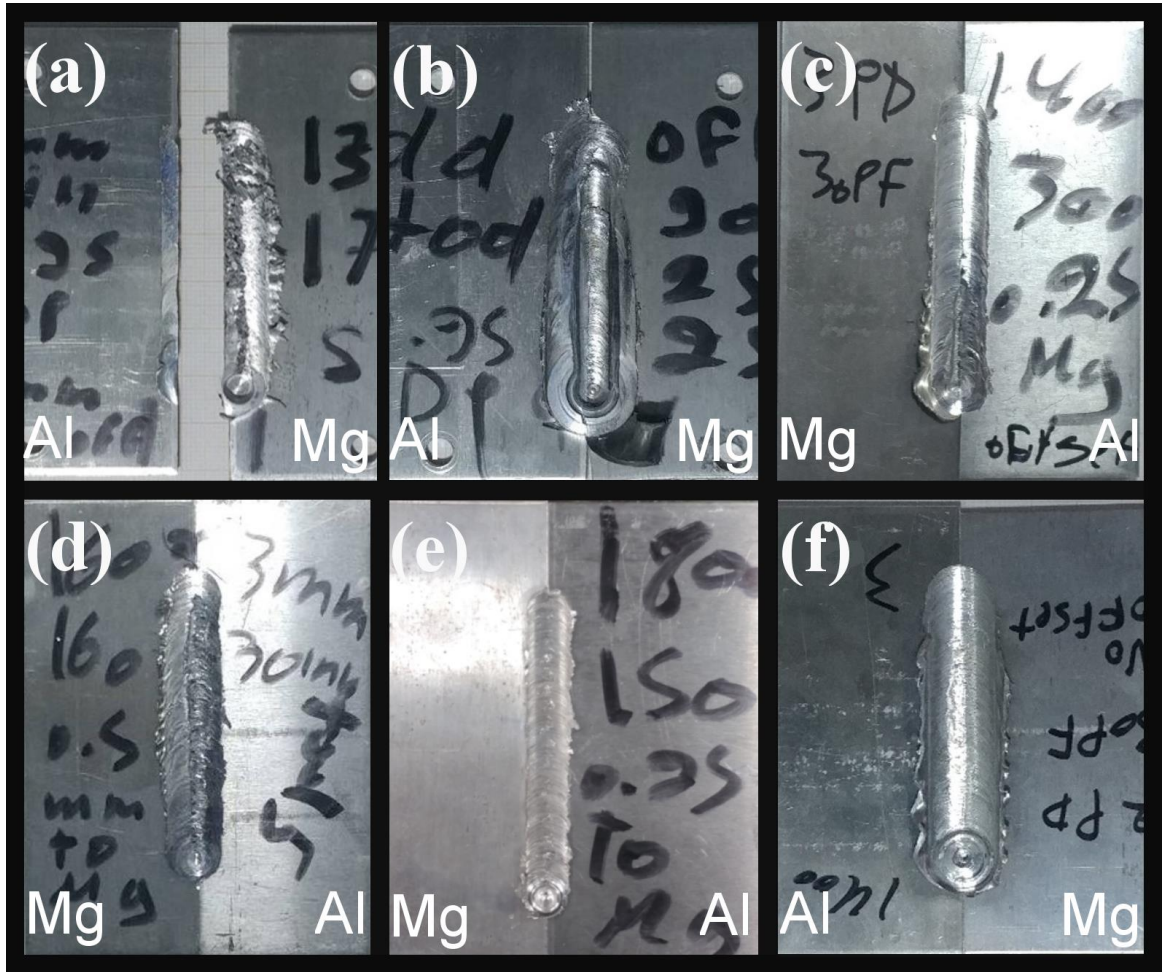
Figure 3 shows a selection of the best samples produced by each tool; the FSW parameters used to produce each weld are presented in table 3. Each sample is numbered after the respective tool used in the FSW operation. Tool (a), as previously stated resulted in excess material shearing at a high rate so that the material was pushed away by the large pin, no mixing took place this can be clearly seen in figure 3 (a). Tool (b) showed similar behavior as well resulting in a similar result to tool (a) figure 3 (b). Sample (c) started with good weld and good surface finish. However, a large groove formed in the end half of the weld. Sample (d) showed a consistent rate of visible defects across the weld length. Sample (e) showed good surface finish across the weld length, and no visible defects were observed in the weld except for a seam line at the interface between the two metals. Sample (f) also showed good surface finish. No visible defects were observed for that sample.

Figure 3 Resulting FSW samples from each tool listed in figure 2 respectively. Sample (a) failed weld from too much deformation. Sample (b) bad weld resulting from too much deformation and material overflow. Sample (c), the welds started well but ended with visible defects. Sample (d), the weld shows consistent visible defects across the weld length. Sample (e) showed no visible defects except for a seam line between the two materials. Sample (f) showed no visible defects.

These results show that as expected the threaded pin tool does indeed result in good material flow and therefore proper mixing, however, this does depend on the dimensions on the features since better results were obtained using tool (e) than tool (f). It was also found that a tool with a small pin would also result in a good weld given the optimal FSW parameters are used.

These experiments showed that for the tools used the ideal speed range is 1300-1800 RPM, the ideal feed range is 150-300 mm/min, and that an offset into the softer material (AZ31B) further improves the weld quality as well. Samples (e) and (f) are selected for the CT X-ray NDT analysis since they show good weld characteristics, and no surface defects were observed in the weld.

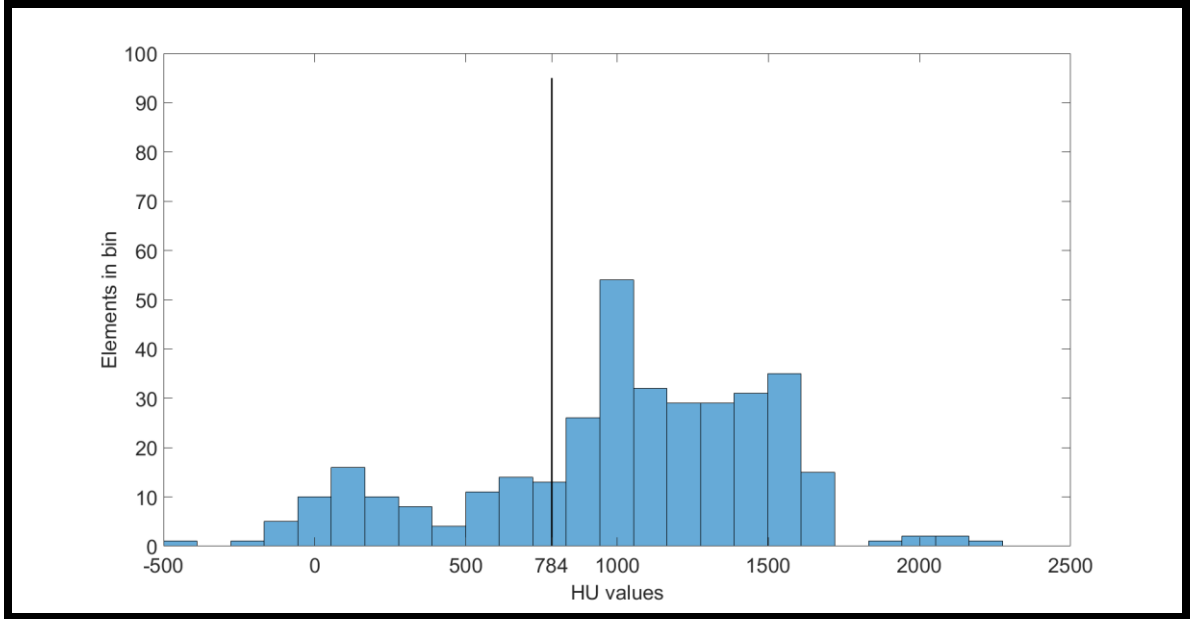
In Hamade and Baydoun [49] the author has previously demonstrated that the Otsu thresholding method can be successfully employed to detect defects in dissimilar FSW lap joints. By applying the Otsu method on a weld cross-section presenting the gray level histogram shown in figure 4 is obtained, also shown in figure 4 is the Otsu threshold value of 784 HU which intermediate to the HU of defects (-1000) and that of Al (1800-2300). The graph showed the expected bimodal shape that is indicative of a background/foreground mode, which in this case corresponds to a material/defect combination. However, because the defect was small, and the pixel resolution low the shape of the defect was not captured accurately [49]. The resulting CT X-ray cross-section is shown in figure 5, and the material mask is shown in light blue. A defect with a size of 8 pixels is detected based on the applied thresholding scheme. This was verified by destructive cutting of the sample at the same cross-section, which showed a pin-hole defect that the expected location as can be shown in figure 6 which is a photograph of the cross-section. The defect is highlighted in white and a marked with the red square.

Figure 4: Grey level histogram of the cross-section of weld case #13, the resulting cutoff HU value of 784 is also shown; taken from Hamade and Baydoun [49].

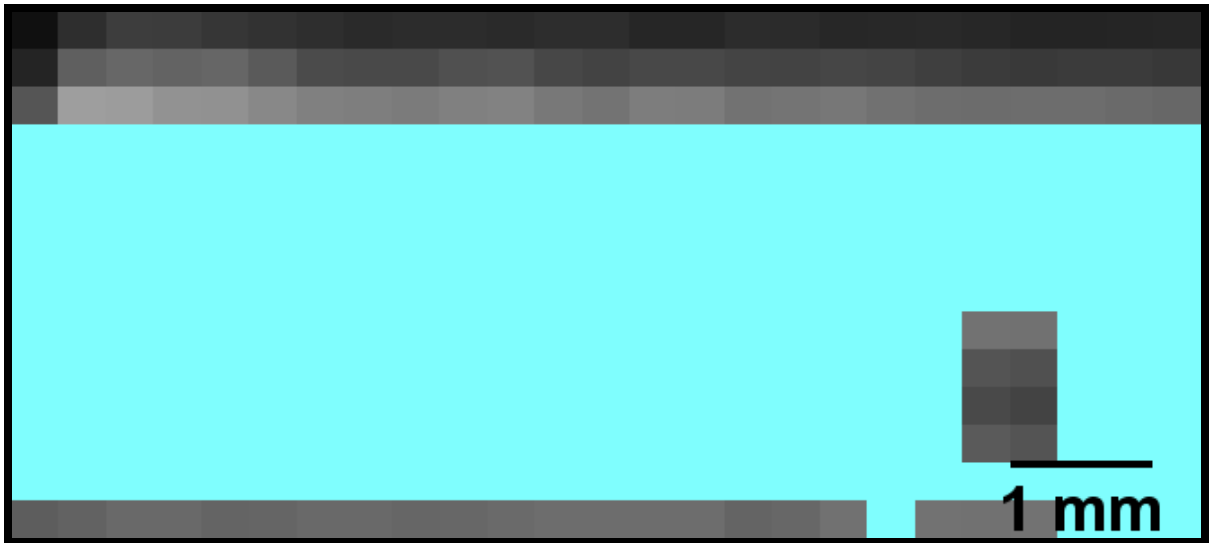
Figure 5 Segmented cross-section of weld case 13, showing the detected defect to the right; taken from Hamade and Baydoun [49].

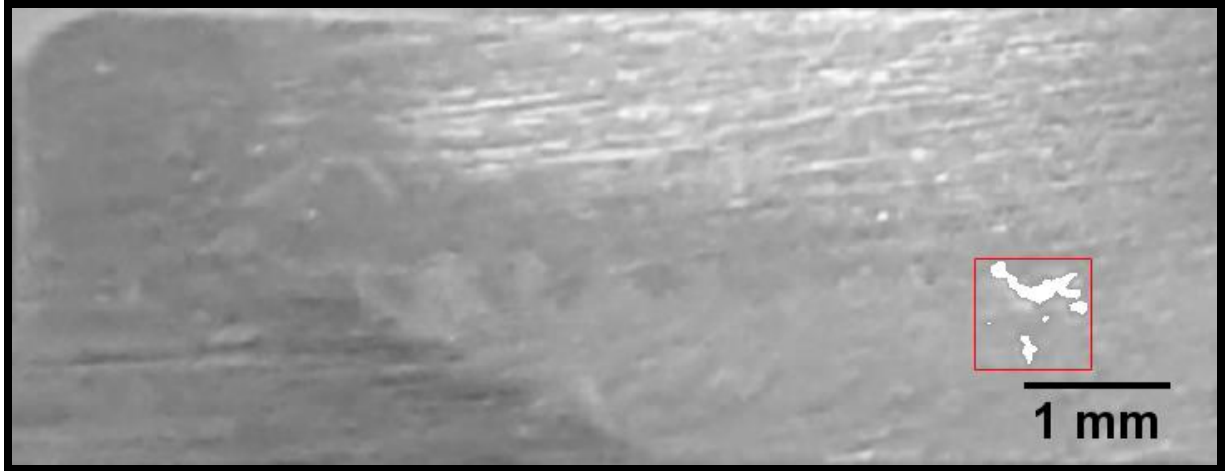
Figure 6 Photograph of the cross-section of weld sample 13 with the pin-hole defect highlighted in white with a red square marker; taken from Hamade and Baydoun [49].

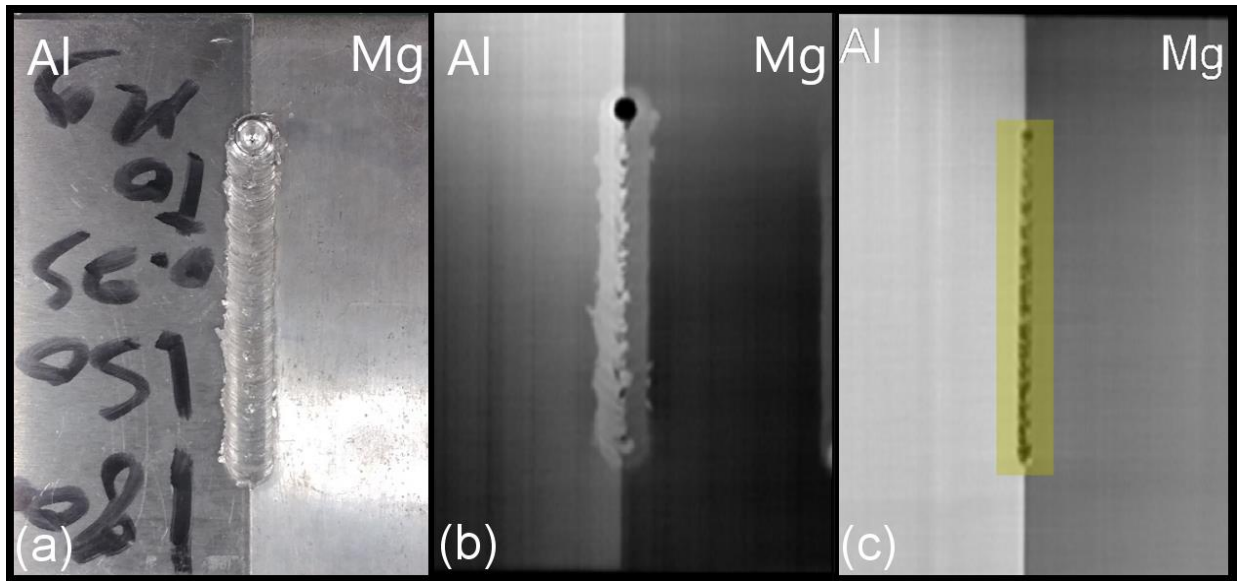
This analysis is first applied to sample (e). The sample is first scanned by the CT X-ray machine, as described in section A of this chapter. Figure 7 (a) shows a top view photograph of the weld sample as well as a CT image (b) shown from the same perspective. By examining the CT X-ray image, it can be noted that the difference between the two alloys AZ31b and AA6061-T6 can already be noted with the AZ31b plate

appearing in a darker gray than the AA6061-T6 plate, this indicates a difference in the HU values of these alloys. The Otsu thresholding method is applied across all the weld length as above mentioned, figure 7 (c) shows in yellow the location where the thresholding was applied.

Figure 7 Weld sample (e), (a) photograph of the weld sample, (b) top view of the unsegmented CT image of the weld sample, (d) top view of the CT images of the sample showing in transparent yellow the location of the Otsu thresholding section.

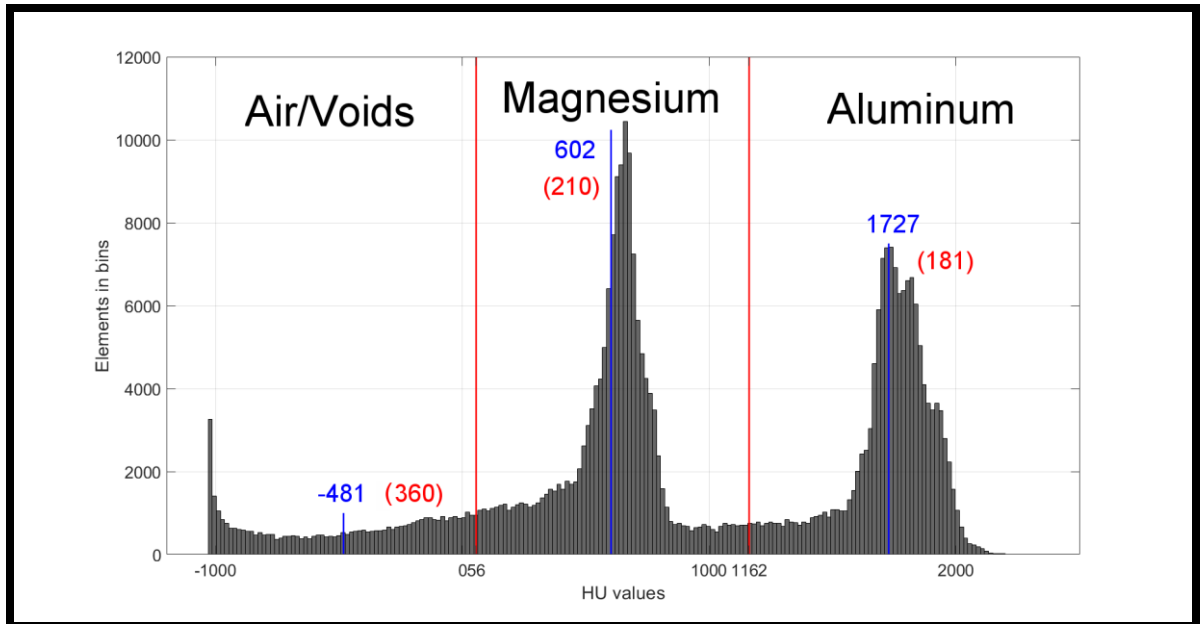
The resulting histogram is shown in figure 8. The histogram has the ideal trimodal distribution corresponding to the three materials present AA6061-T6 AZ31b and air (defects and voids), thus making the histogram segmentation reliable and accurate. The threshold values are shown on the X-axis and segment the histogram via a vertical red lines; the reliability measure of this segmentation is 0.918. The two thresholds are 56 HU and 1162 HU. For each segment the mean HU value is calculated (shown with a blue line) as well as the standard deviations (shown in red quotations). The mean HU value of AA6061-T6 is 1727 HU which is around the expected theoretical range, separated by

around 1100 HU from the mean HU value of the AZ31b at 602 HU. The internal defects (voids) show a mean HU value of -481HU the negative value indicate that it corresponds to air, but due to the averaging process with nearby material pixel this value is shifted from the theoretical -1000 HU value. For the magnesium (AZ31b) region the majority of the elements are within one standard deviation of the average value in a symmetrical manner, however, for the aluminum (AA6061-T6) region the peak shows a clear trailing edge with a secondary peak at 1920 HU. For the defect region, the standard deviation is significant due to the shape of the region, the main peak for the defect region is at -1000 HU which shows a sharp decrease -850 HU, at this value the decrease in bin elements is halted until around 700 HU where the bin elements start to gradually increase again. The defect region exhibit an inverse bell-shaped distribution with a pronounce peak the left-most side and a slight peak at the right-most side, this is due to the fact that the ideal value for defect region at an extremely high-resolution scan with no averaging phenomenon is -1000HU, but since the averaging process is still observed at the valley between the peaks of the defect and material segment still shows a consistent number of elements. The aim of employing the Otsu thresholding is to separate these elements into the different material segment in the best way as to preserve the accuracy of any measurements taken from these CT images.

Figure 8 HU histogram for the Otsu thresholding method, calculated thresholds are shown with a vertical red line, mean values for each segment is shown with a vertical blue line and standard deviations in red quotations.

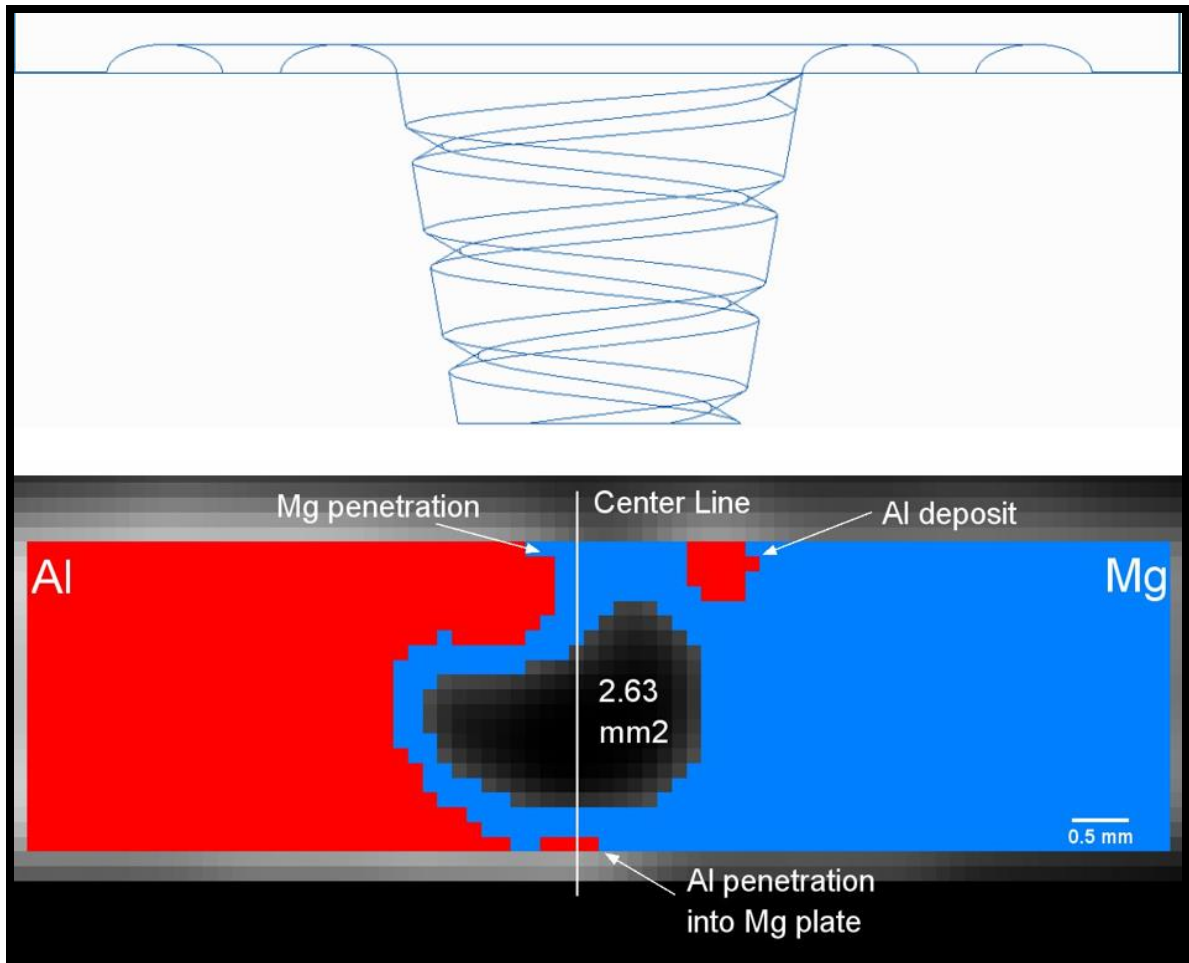
Figure 10 shows a zoomed-in view of cross-section A-A of sample (e) on top of which the tool outline is shown using the same scale as the cross-section. In this figure, the AA6061-T6 material penetration is more evident mainly the AA6061-T6 deposit at the top of the weld that is separated from the main plate body of the AA6061-T6 alloy indicating that the threaded pin resulted in a depositing/mixing action that is atypical of this pin geometry. There is some AA6061-T6 penetration that is detected on the bottom of the plate as well while the primary AZ31b penetration into the AA6061-T6 is mainly detected at the middle of the cross-section. As for the tunneling defect the cross-sectional area of the defect is measured as  $2.63\text{mm}^2$ . The tunnel is further indication of atypical mixing action taking place. Ideally internal defects would be much smaller, this weld, however, can still be used as an example of this method’s ability to evaluate and defects.

Figure 10 Zoomed-in view of cross-section A-A (bottom), the centerline of the weld is marked with a vertical white line. The material mixing is indicated with arrows; the defect area is shown, (top) outline of the tool used for sample (e) shown at the same scale.

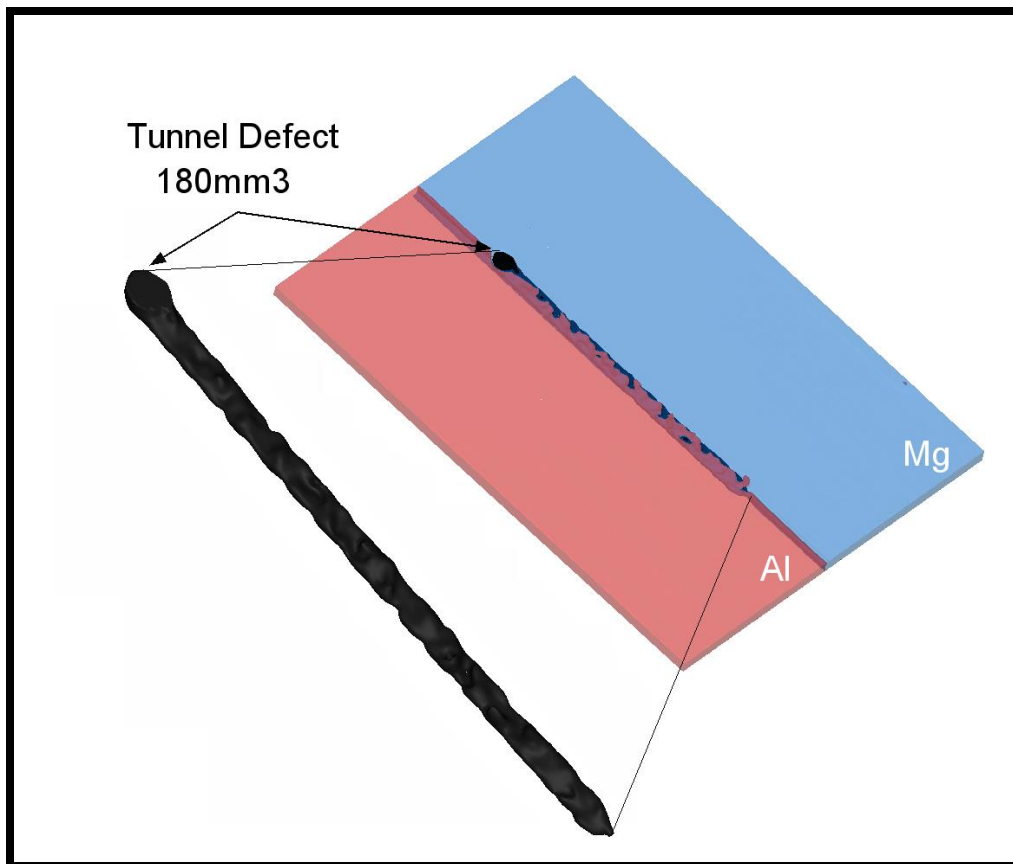
To measure the volume of the detected tunneling defect, a 3D object was constructed for the internal defects as well. Figure 11 shows this 3D reconstruction, the AA6061-T6 and AZ31b plates are shown in transparent red and blue respectively, the tunneling defect is shown in solid black, 3D volume measurements show that the tunneling volume is  $180\text{mm}^3$  with the exit hole and  $164\text{mm}^3$  excluding the exit hole. Alternatively, the defect volume can be calculated based on the number of pixels in the void mask, the tunnel mask contained a total of 32386 elements, with a voxel size of  $0.00566\text{mm}^3$  this

leads to a tunnel volume of  $183\text{mm}^3$ , this is a volume increase of 1.6%. The NDT of the tunneling defect highlights the need and importance of the NDT and NDE of FSW joints since after the NDT analysis was carried out the quantitative data (volume and cross-sectional area) were calculated, allowing for a deeper understanding of the effect of pin geometry and FSW parameters on the generation of internal defects.

Figure 11 3D rendering of the weld sample shown in transparent red and blue, the tunneling defect is shown in solid black with a zoomed-in view to the left.

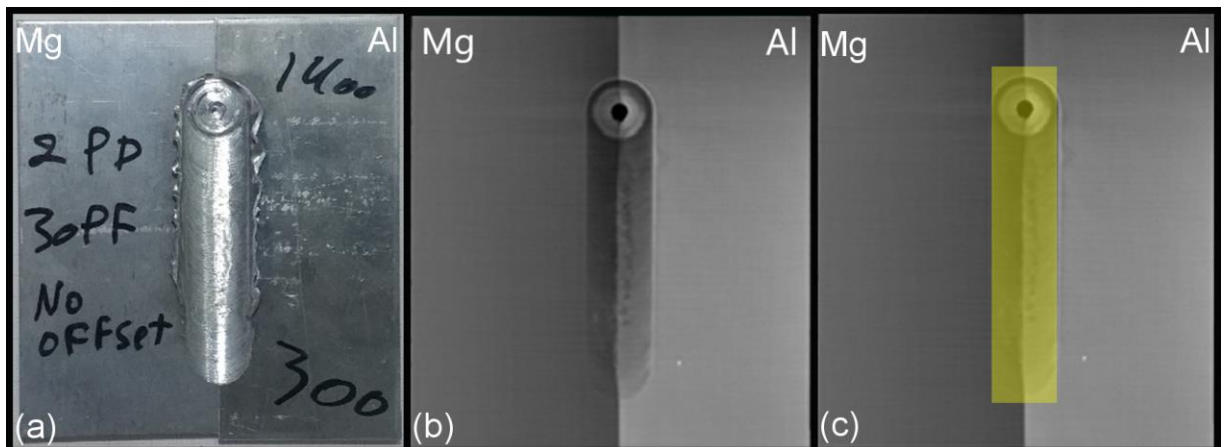
The NDT method is applied to weld sample (f); the same methodology is adopted. Figure 12 (a) shows a photograph of the weld sample, figure 12 (b) shows the non-segmented CT image of the weld sample, again it can be noted that the AA6061-T6 plate appears in a lighter shade of gray than the AZ31b alloy plate. Figure 12 (c) shows in yellow the location where the Otsu thresholding was applied, which is the entire weld length. The sample showed the best surface finish of the other weld samples.

Figure 12 Weld sample (f), (a) top view photograph of the weld, (b) top view CT image of the weld, (c) top view CT image of the weld sample shown in yellow is the location of the application of the Otsu thresholding

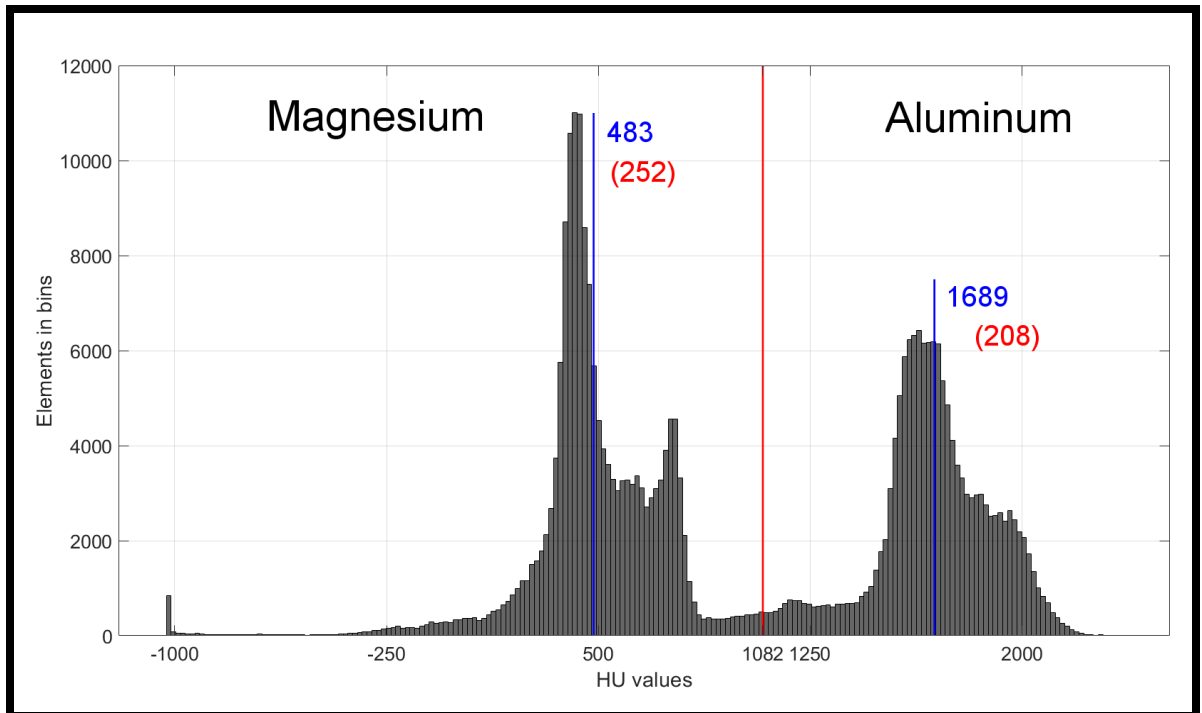
The HU level histogram for sample (f) is shown in figure 13, in this case also a trimodal distribution is observed, however the peak at the -1000 HU value is significantly smaller than the peaks at 483 HU (AZ31b peak) and 1689 HU (AA6061-T6 peak). This is indicative of the absence of internal defects, the small peak that is shown is related to the exit hole of the weld more evident when comparing with the HU histogram of sample (e) the elements in bins -250 to -1000 is significantly reduced further confirming the absence

of defects. The recorded HU mean values for both alloys is 483 HU and 1689 HU respectively for AZ31b and AA6061-T6. Since no defects were detected the threshold between the AZ31b and air (voids/ defects) is not needed. The histogram also shows secondary peaks next to the right of both peaks; this is indicative of proper mixing because the interface pixels (pixels located at the interface between the two materials) will have HU values that are intermediate to the HU values of both alloys taken separately. This is not observed in the HU histogram of sample (e) due to the presence of the tunneling defect. Both alloys have an extensive interface with air (defects) and thus the change in HU occurs mostly from the materials mean HU value to -1000 at a fast pace due to the high pixel resolution of the scan and the broad range between the two mean values especially when compared to the range between the mean HU values of both alloys. The Otsu thresholding for sample (f) resulted in a threshold value of 1082 HU, with a reliability measure of 0.871.

Figure 13 HU level histogram of weld sample (f). The threshold value indicated by a red vertical line, each segment is labeled, the average HU value for each segment is shown in blue and indicated by a blue line, the standard deviation values are shown in brackets.

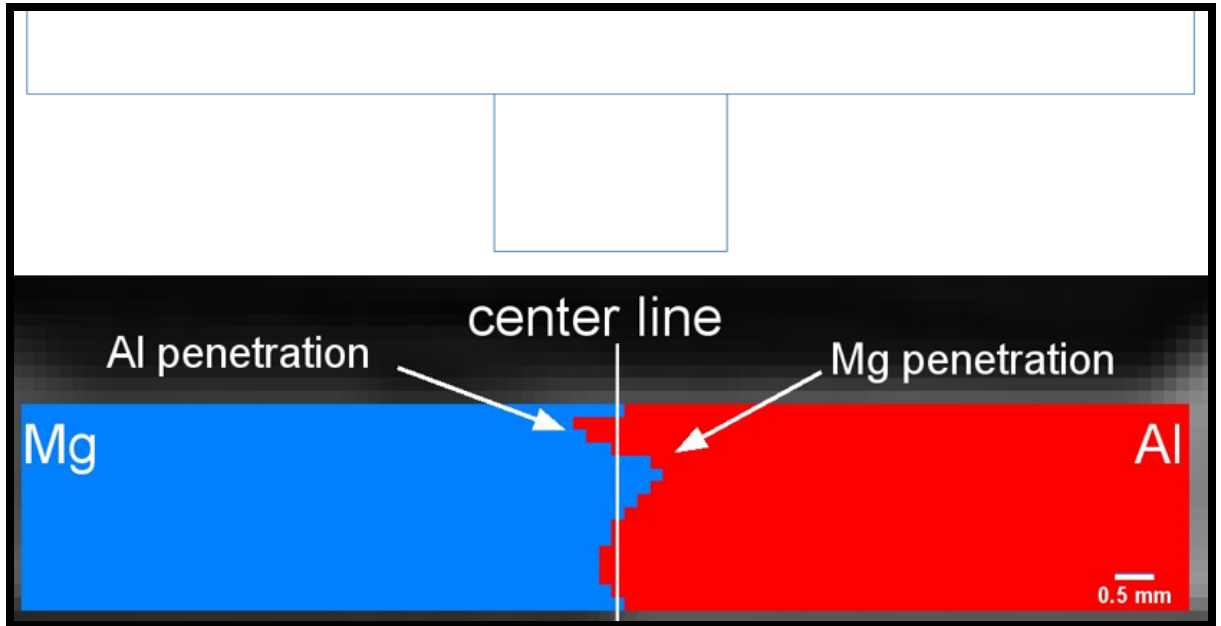
Figure 15 shows cross-section A-A of the weld. The centerline of the weld is shown in white, and the material penetration is indicated with arrow marks. The material mixing analysis shows an oblique interface with the AZ31b penetration into the Aluminum alloys taking place at about 1mm below the top of the plate, the maximum penetration of the AA6061-T6 into the magnesium alloy taking place at 0.3mm from the top of the plate. The maximum penetration depths for this cross-section are recorded as 0.6mm from the weld centerline for both alloys. No defects were detected in the weld, aside from a small tunneling defect connected to the exit hole that penetrated 3mm into the weld. This defect is not considered internal since it can be detected by visual inspection by looking into the exit hole. The NDT testing is still beneficial however since the CT X-ray scan can be used to measure the volume of the defect as well as the penetration depth into the weld.

Figure 15 Zoomed-in view of cross-section A-A (bottom) the centerline is shown with a vertical white line, the material mixing is highlighted with arrows, (top) outline of the tool used for sample (f) shown at the same scale.

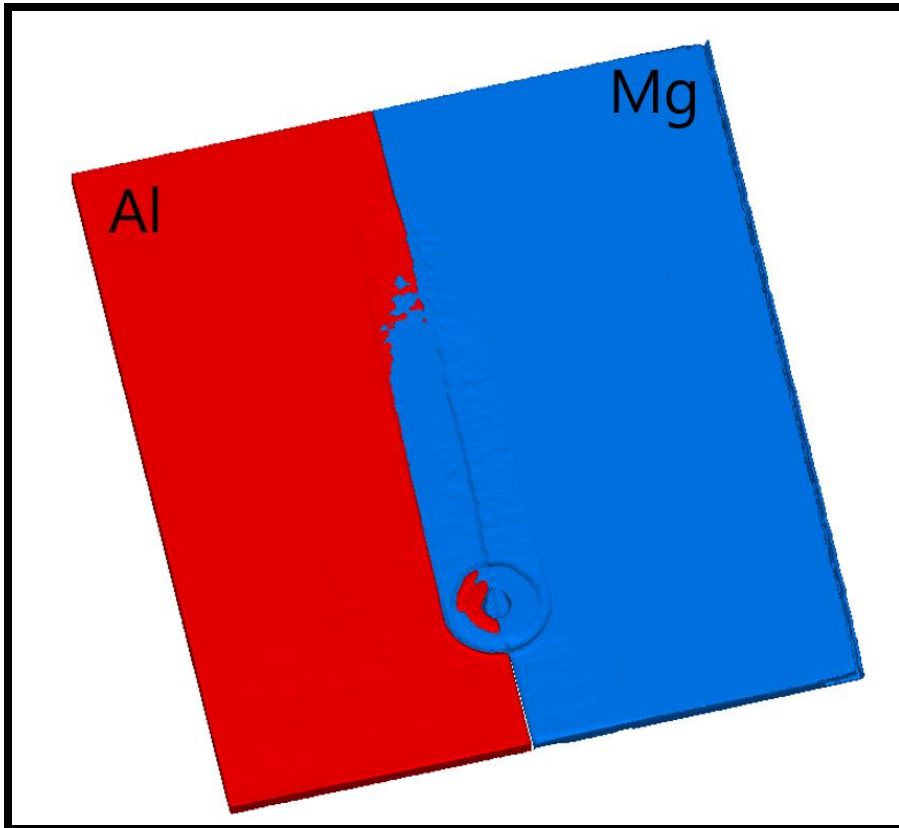
Figure 16 shows the 3D model of the weld sample. The material transfer at the top surface of the weld is clearly shown, measurements of the material transfer show that the  $103 \text{ mm}^3$  of the AZ31b alloy was transferred to the aluminum alloy plate, while  $31 \text{ mm}^3$  of the AA6061-T6 was transferred to the magnesium alloy. This may be attributed to the fact that compared to sample (e), sample (f) had the AZ31b as the advancing plate and since it is the softer of the two materials a more substantial material transfer was observed for the AZ31b alloy on the top surface of the plate.

Figure 16 3D rendering of weld sample (f) the top surface AZ31b material deposit is evident.

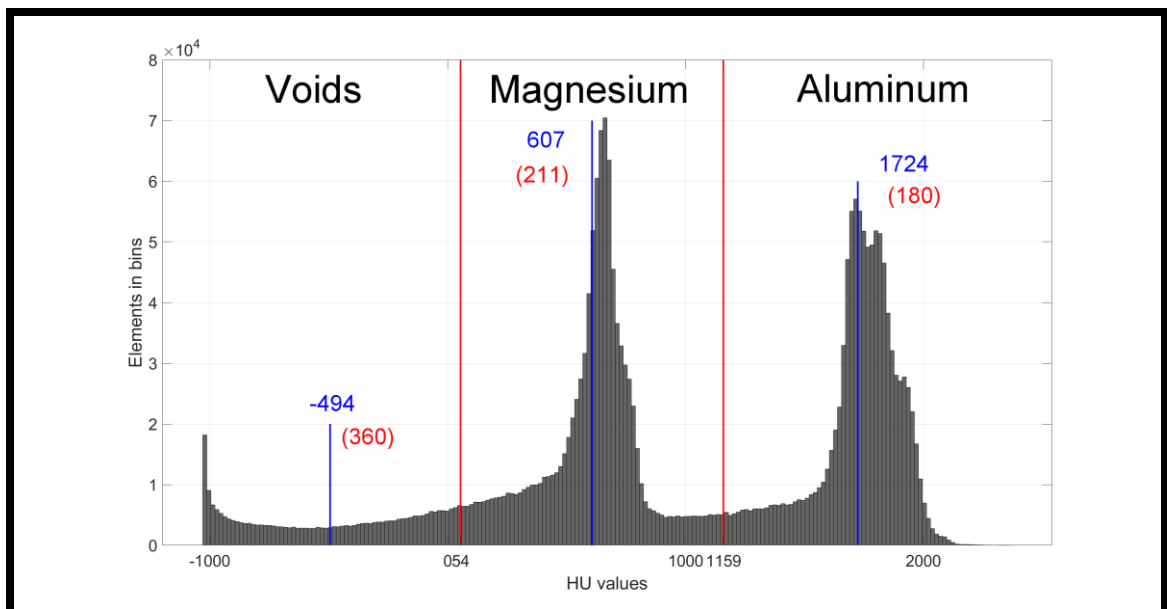
The mean and standard deviation values for the three segmented regions showed similar miniscule changes in values.

Figure 17 HU level histogram of reconstructed images of weld sample (e). the threshold value indicated by a red vertical line, each segment is labeled, the average HU value for each segment is shown in blue and indicated by a blue line, the standard deviation values are shown in brackets

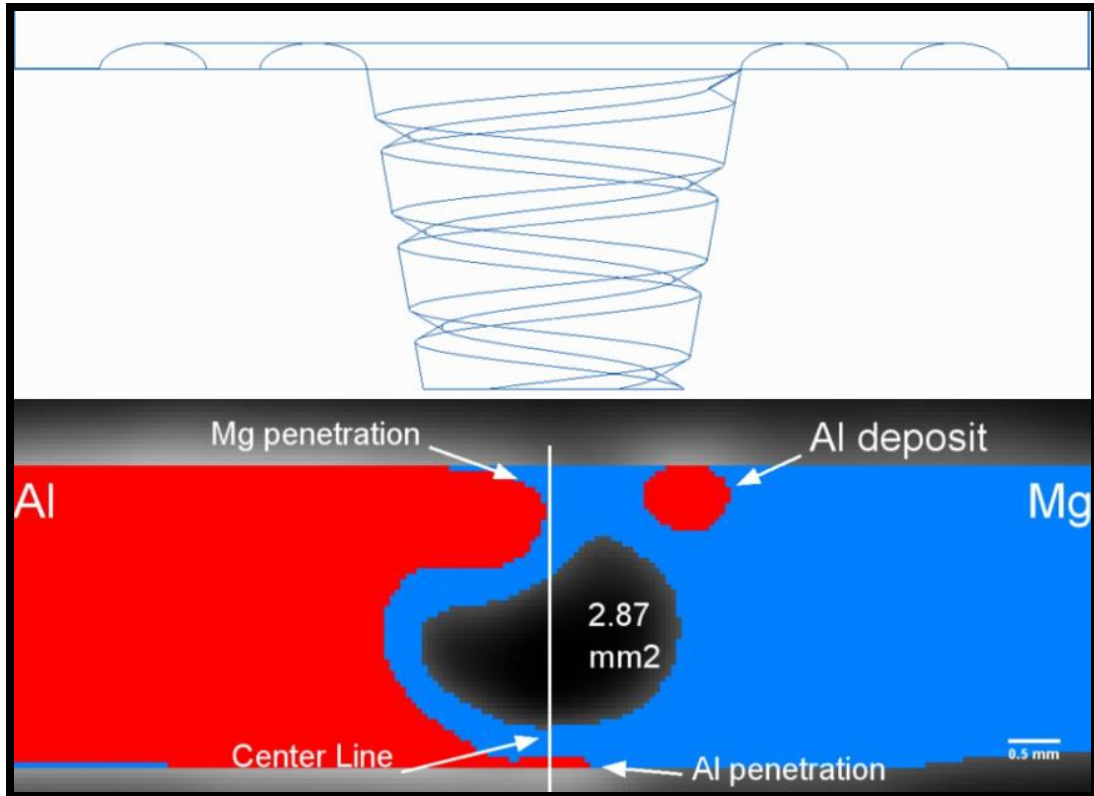
The reconstructed cross-section A-A for sample (e) is shown in figure 18, the same features as the original cross-section are present. The features, however, have a more gradual profile due to the higher pixel density. This results in a change in the measured areas. The cross-section of the tunneling defect now has a measured area of  $2.87\text{mm}^2$  an increase of 9% over the original areal measurement. The AA6061-T6 deposit, as well as the penetration at the bottom, present a more definite shape as well. As for the volume of the tunneling defect, the same overall shape is observed as the one shown in section C; however, the volume measurement showed an increase of  $5.6\text{mm}^3$  over the original measurement of  $180\text{mm}^3$ , an increase of 3%. Calculating the tunnel volume from the tunnel mask results in a volume of  $182\text{mm}^3$  this is calculated based on the number of elements in the mask (217690) and the pixel size and slice thickness.

Figure 18 Zoomed-in view of reconstructed cross-section A-A (bottom), the centerline of the weld is marked with a vertical white line. The material mixing is indicated with arrows; the defect area is shown, (top) outline of the tool used for sample (e) shown at the same scale.

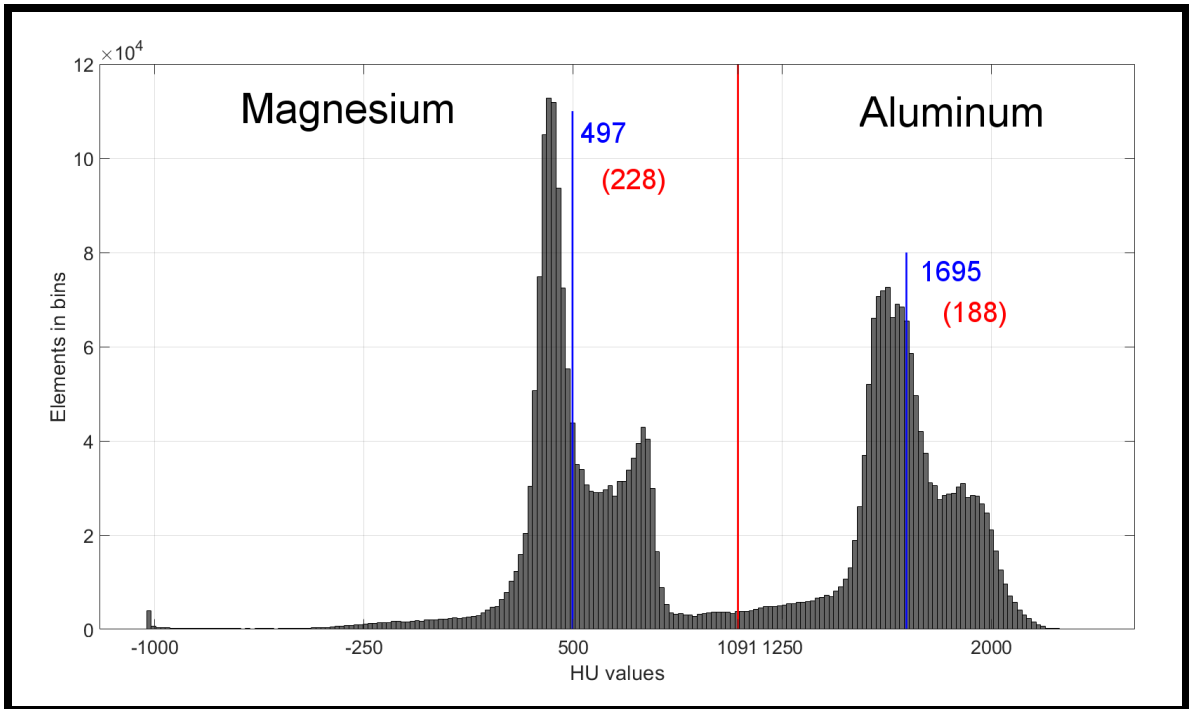
The same analysis is repeated for sample (f). Figure 9 shows the HU histogram, again compared to the histogram of the original sample, nearly the same values for the thresholds, averages, and standard deviations are observed. The histogram shows a more gradual distribution around the peaks, and this is due to the increased pixel density resulting in more elements spanning the HU range for each segment more evenly. The HU threshold value calculated is 1091, with an effectiveness measure of 0.890. Compared to the original threshold of 1082HU and effectiveness measure of 0.871, the HU threshold varied by 0.831% and the effectiveness measure improved by 2.18%.

Figure 19 HU level histogram of reconstructed CT images of weld sample (f). The threshold value indicated by a red vertical line, each segment is labeled, the average HU value for each segment is shown in blue and indicated by a blue line, the standard deviation values are shown in brackets.

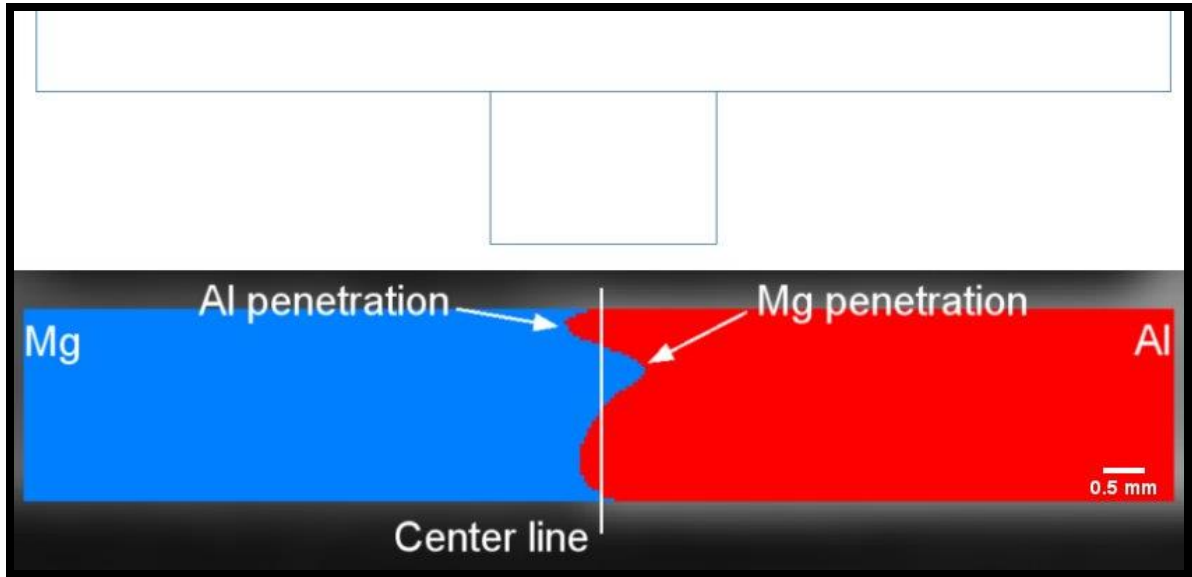
Figure 20 shows the reconstructed cross-section A-A of sample (f), the mixing interface between the materials has the same rough shape as the original cross-section however near the bottom half of the sample more AZ31b penetration is observed. The maximum AZ31b penetration into the aluminum alloy plate is still measured as 0.6mm from the centerline. The maximum AA6061-T6 is 0.5mm, showing a 0.1mm decrease from the recorded measurement on the original cross-section.

Figure 20 Zoomed-in view of the reconstructed cross-section A-A (bottom) the centerline is shown with a vertical white line, the material mixing is highlighted with arrows, (top) outline of the tool used for sample (f) shown at the same scale.

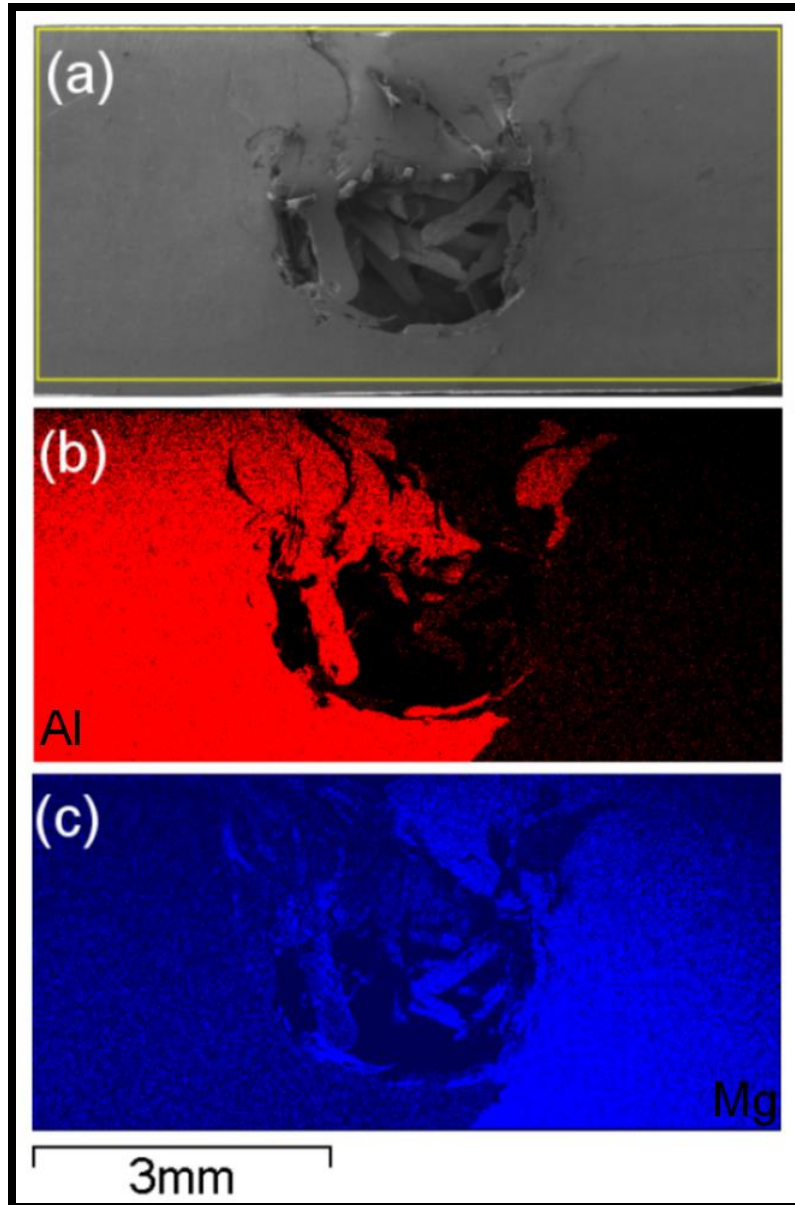
Figure 23 shows the results of the elemental mapping analysis of sample (e). Figure 23 (a) shows the location of the EDX scan; it can be seen that the tunneling defect is filled with material shavings or filaments, due to the plastic shearing action taking place and poor mixing. Figure 23 (b) shows the aluminum elemental mapping, as noted from the point spectrum analysis the aluminum deposit is present, the elemental mapping allows for a more definite shape to be visualized, it also noted that to the left of the centerline. At the middle of the cross-section the sheared off filament is mostly aluminum as indicated by the color red; however, some magnesium is detected that is above the baseline concentration of the AA6061-T6 alloy as is shown in figure 23 (c). At the bottom of this filament and above it is also noted that there is some magnesium present, showing that the segmentation in that area is correct, but due to the averaging process, the mixing appears more pronounced in the CT X-ray scans.

Figure 23 Elemental mapping destructive verification of sample (e). (a) cross-section A-A a yellow rectangle indicates where the mapping analysis was performed. (b) aluminum map, red indicates high aluminum detection. (c) magnesium map, blue indicates high magnesium detection.

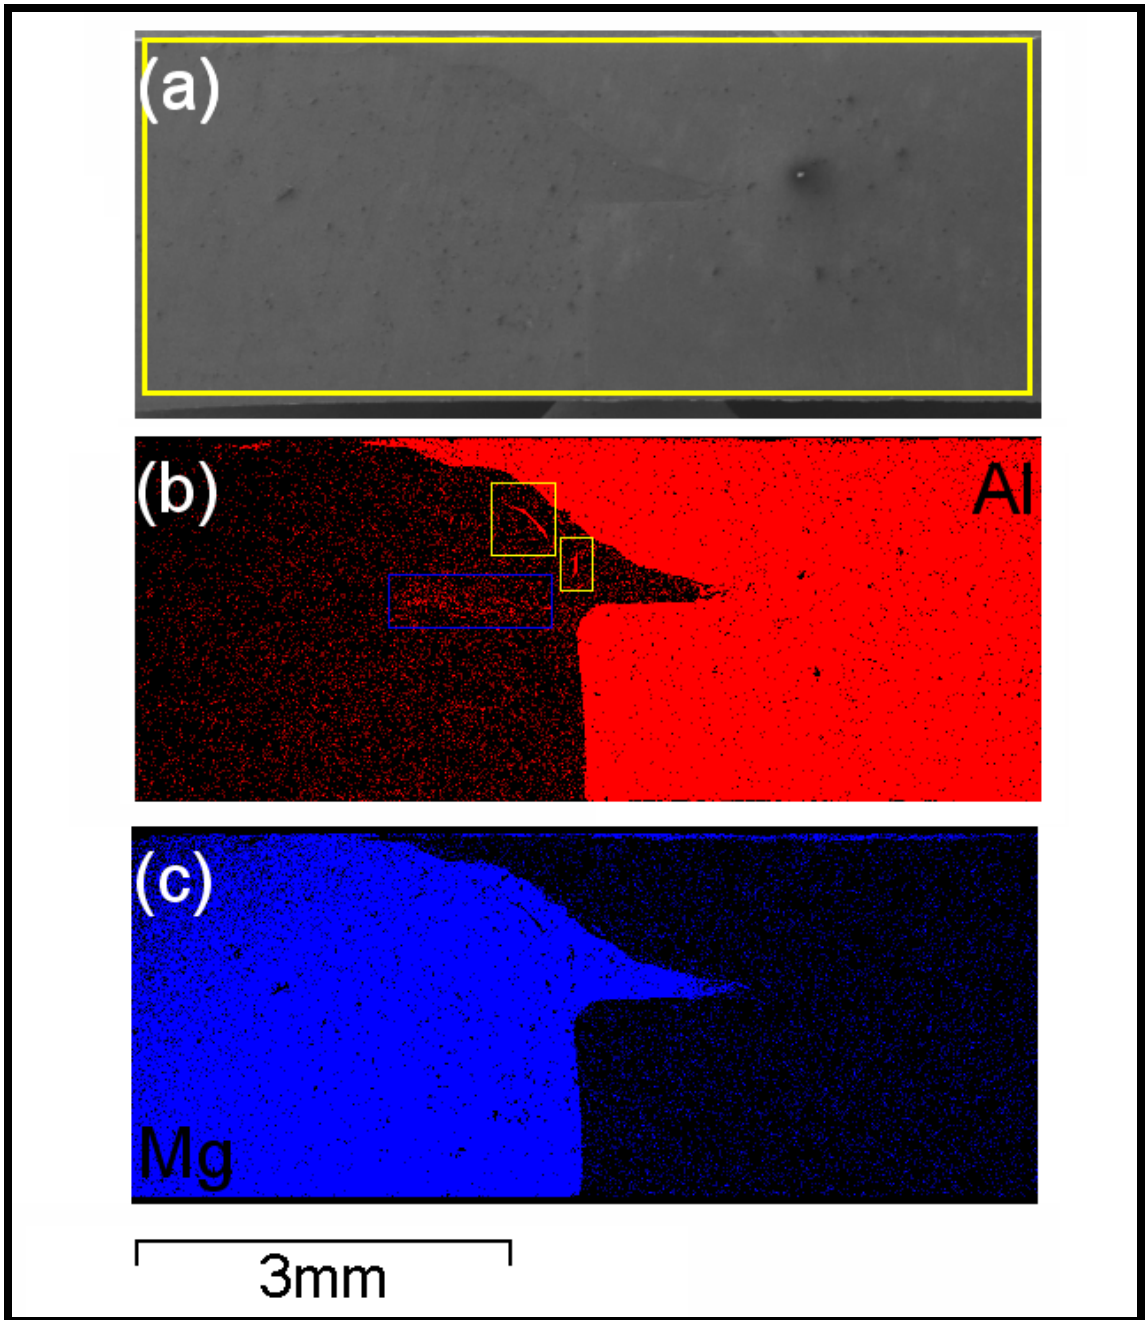
Figure 26 shows the elemental mapping analysis for sample (f). Figure 26 (a) shows the location where the scan was performed. Figure 26 (a) and (b) shows the elemental map for the aluminum and magnesium elements respectively. The mapping analysis results show the same interface structure as the point spectrum analysis, but with a higher level of details. For example, figure 26 (b) shows the two aluminum deposits in the AZ31b plates indicated with yellow rectangles, figure 26 (c) corroborates that with lack of blue color at those two locations. At the bottom of the pin length a higher concentration of aluminum compared to the base aluminum concentration of the AZ13b alloy, indicative of material transfer at that location, this is indicated by a blue rectangle in figure 26 (b). As for the penetration measurements, the maximum recorded penetration for both samples measured 1mm from the center-line, compared to the measurements obtained in section D of this chapter that is a 0.4mm error. This error can be mitigated by further increasing the scanning and reconstruction resolution of the CT images.

Figure 26 Elemental mapping destructive verification of sample (f). (a) cross-section A-A a yellow rectangle indicates where the mapping analysis was performed. (b) aluminum map, red indicates high aluminum detection. (c) magnesium map, blue indicates high magnesium

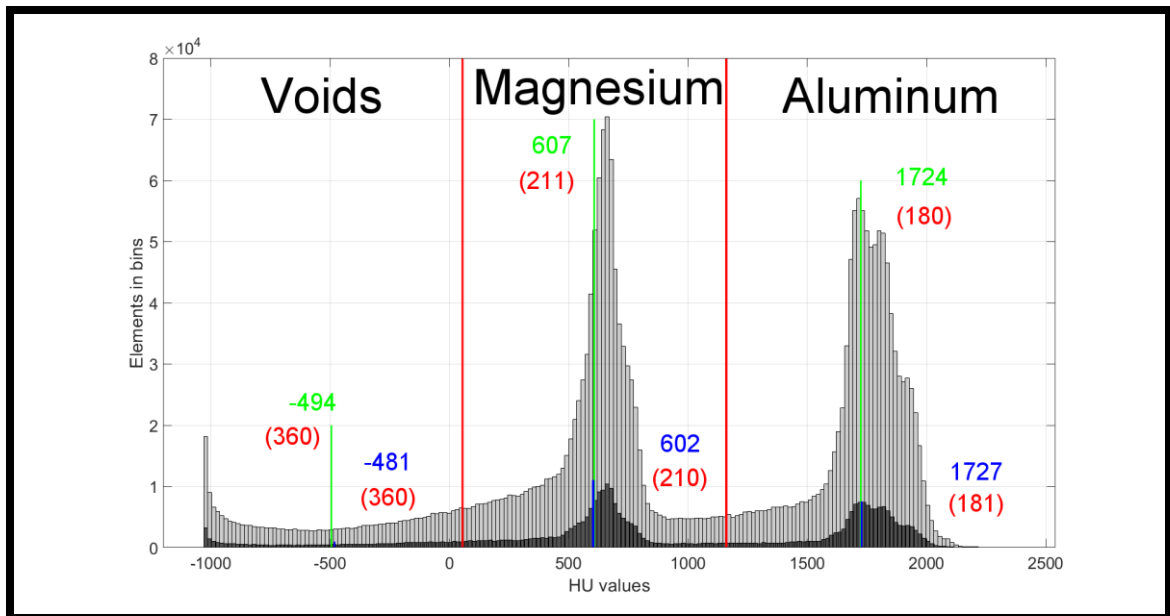
of 2.18%. Figure 27 shows the histogram of the original and reconstructed NDT analysis of sample (e), the total number of elements analyzed for the original and reconstructed sections are 338800 and 2349696, respectively. This increase in number of element number of nearly 7 times, is the main reason for the Otsu accuracy improvement. The histograms of sample (e) show a similar shape for the peaks and valleys. The histograms also showed nearly the same values for the mean, and no significant improvements were measured for the standard deviations for this sample.

Figure 27 Otsu HU histogram of sample (e), transparent black: histogram of the reconstructed cross-sections, solid black: histogram of the original cross-sections.
