NON-DESTRUCTIVE EVALUATION OF MIXING AND  
DEFECTS OF FRICTION STIR WELDED DISSIMILAR AA6061-  
T6 AND AZ31B BY X-RAY COMPUTED TOMOGRAPHY.

A thesis  
submitted in partial fulfillment of the requirements  
for the degree of Master of Engineering  
to the Department of Mechanical Engineering  
of the Maroun Semaan Faculty of Engineering and Architecture  
at the American University of Beirut

Beirut, Lebanon  
August 2019

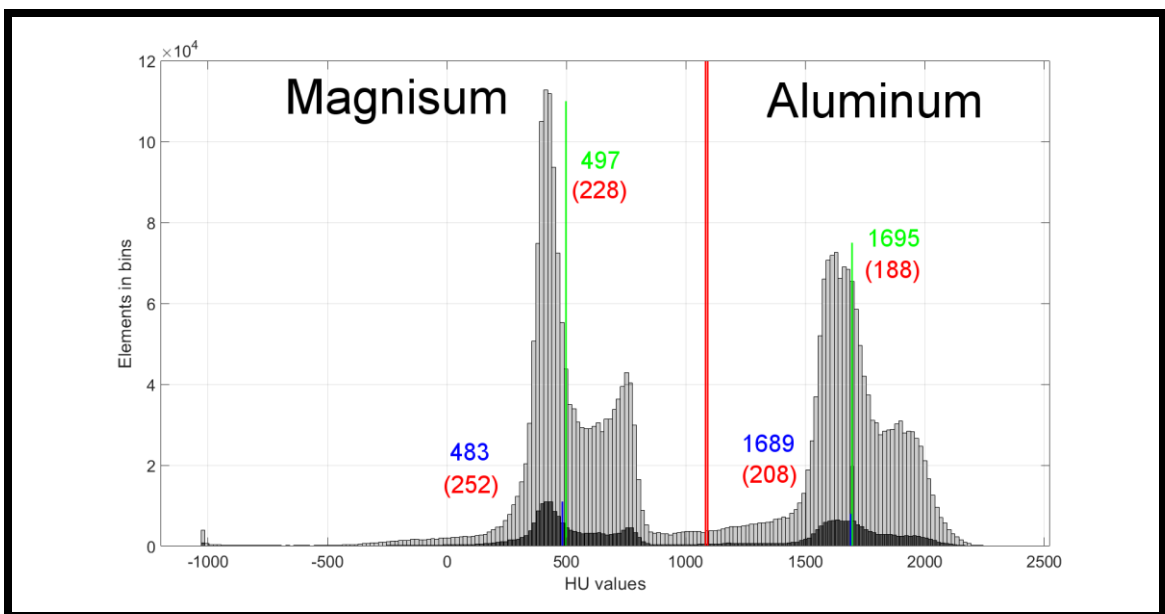
thresholding method. the changes in the mean values for each segment changed by 2.89% and 0.35% for the AZ31b and AA6061-T6 respectively, as for the standard deviations, the variations improved by 9.52% and 9.61% respectively for the AZ31b and AA6061-T6 sections. Based on these results, it is concluded that reconstructed sections can be used to achieve better thresholding results as well as increase the shape accuracy of the CT images.

Figure 28 Otsu HU histogram of sample (f), transparent black: histogram of the reconstructed cross-sections, solid black: histogram of the original cross-sections.

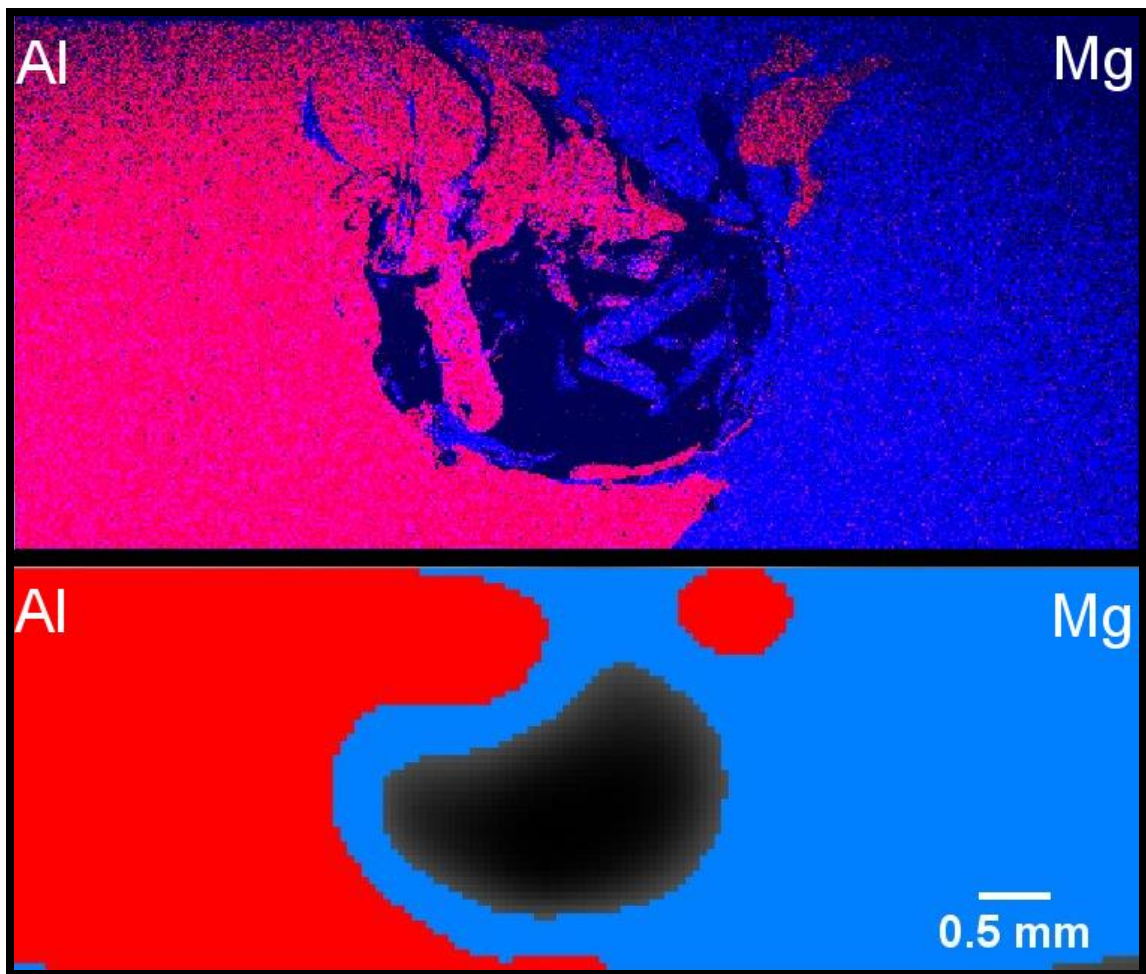
and 29 (bottom) show the reconstructed cross-sections of both samples. For sample (e) the tunneling defect was successfully detected as well at the aluminum deposit and bottom aluminum penetration into the AZ31b plate. The magnesium penetration on the surface of the AA6061-T6 plate is also detected, as well as the magnesium around the tunneling defect.

Figure 29 Sample (e), (top) combined EDX elemental analysis of cross-section A-A, (bottom) reconstructed cross-section A-A.

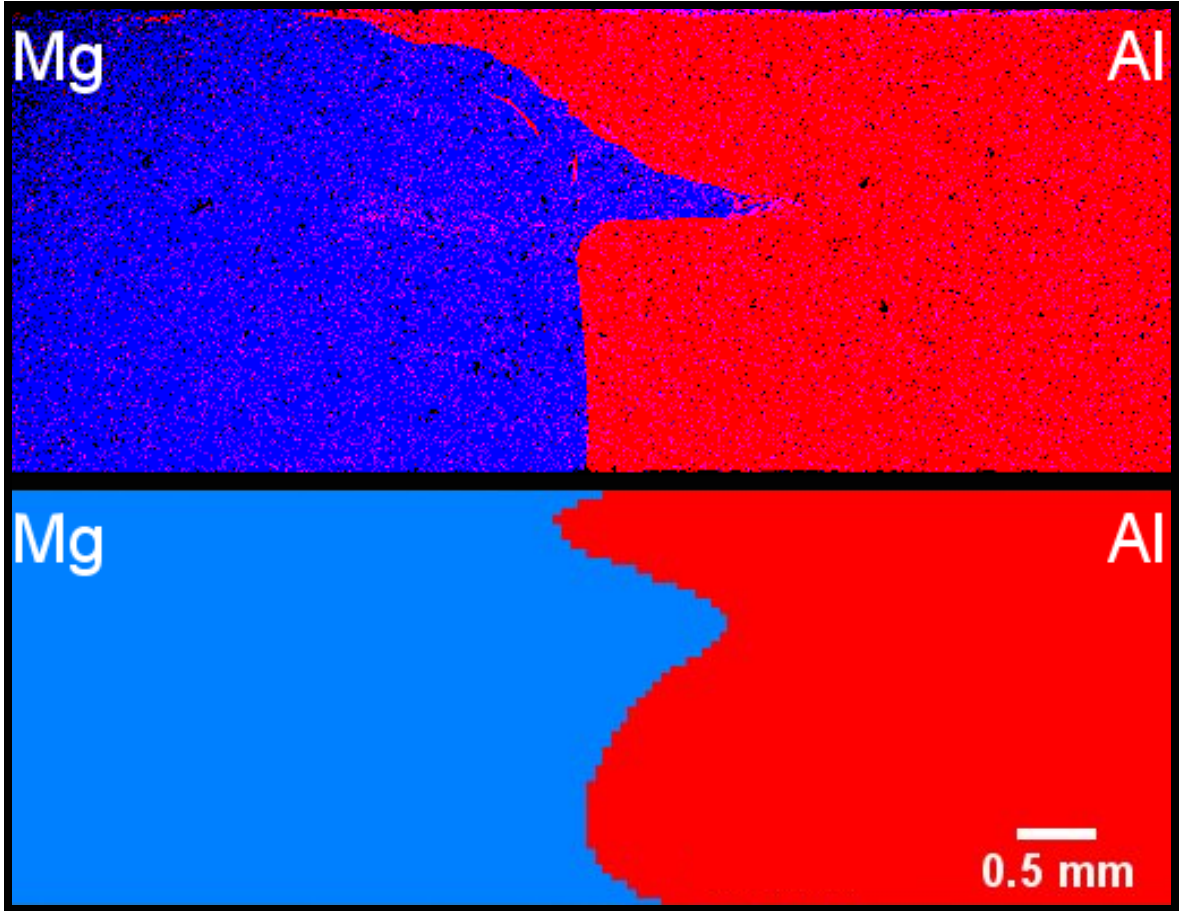
For sample (f) shown in figure 30, the interface shape was accurately detected. The EDX analysis for this sample also shows that at the oblique interface between the two materials the number of violet pixels is larger than that of the vertical interface where no welding took place, this is most evident at the tip of the AZ31b penetration where a large amount of violet pixels is observed, this shows that for those pixels both Al and Mg elements were detected, which may indicate the presence of intermetallic compounds at this location. These violet pixels are also observed in the left filament of tunneling defect shown in figure (29). The presence of these intermetallic compounds in sample 29 can explain the formation of the tunneling defect since the high hardness of the intermetallic compounds can cause excessive shearing actions removing materials from the base metal as they are moved by the welding action.

Figure 30 Sample (f), (top) combined EDX elemental analysis of cross-section A-A, (bottom) reconstructed cross-section A-A.
